## RYZUK GEOTECHNICAL

Westridge Development Area, near Valemount BC,  
Formal Notice of Road Closure at: 16.25 km, Westridge Forest Service Road,  
UTM Location, 338,077m E, 5,857,326m N, 1,240m Elevation

This letter is the formal, written, "**Notice of Road Closure**".

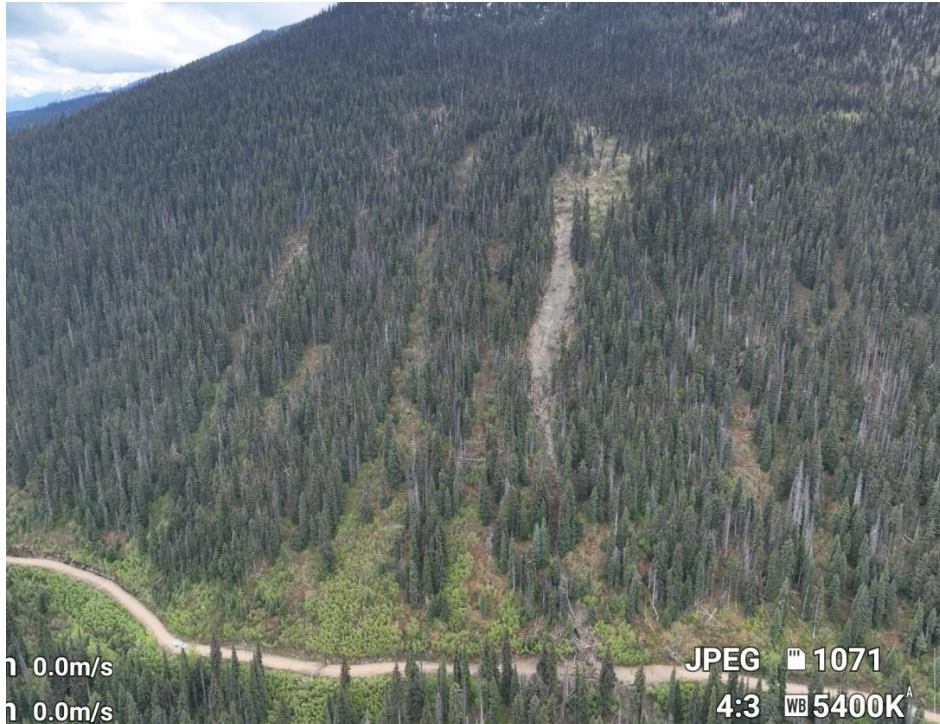
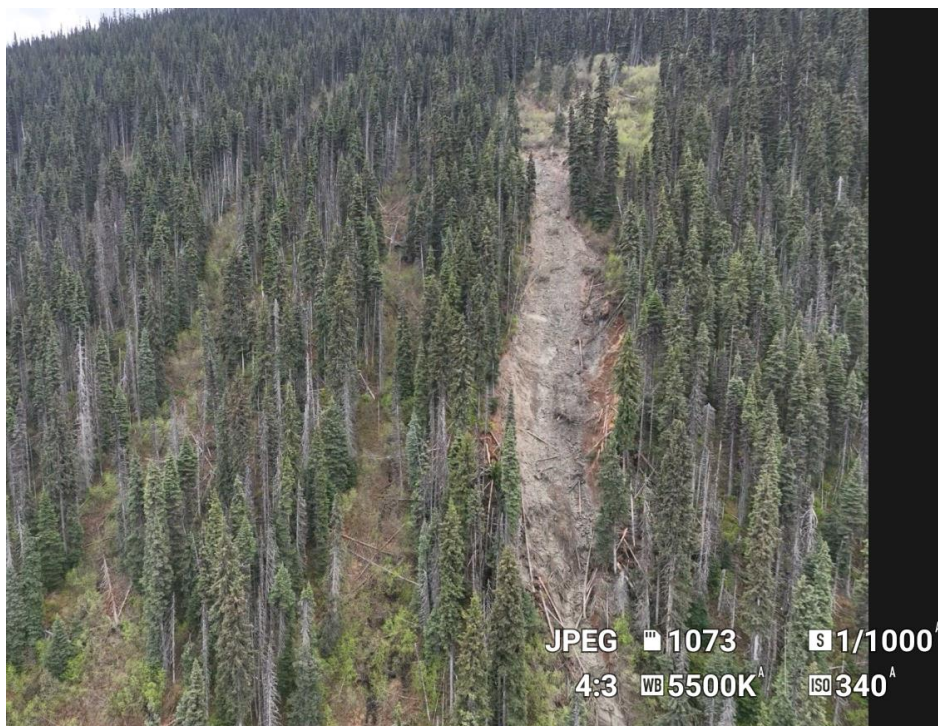
Photographs (June 05, 2024)

To many observers, the slide as it appears at the road elevation may not seem very dramatic. At elevation however, the amount of water flowing down the slide increases dramatically if compared with flows observable at the road elevation. Huge volumes of partially saturated and saturated material also occur over the bulk of the elevation range from 1,290m± elevation, and up to the initiation point at 1,441m±. The majority of these volumes may experience large scale additional displacements at any time. Rainy weather may or will increase the frequency and volume of any, and all further displacements for many weeks yet.

The remarked difference in appearance at the road elevation compared with the higher initiation elevation, and with the gutted run out descent length below, is apparent in the photos on page 2.

Presently, the slide area and a 750m perimeter around the entirety of the slide footprint, are rated as a very high risk zone for persons on foot or using motorized vehicles, bicycles, horses or other modes of transport.

The road shall remain closed to all persons and all motor vehicles until further notice. Geotechnical engineering analysis of the event has now commenced.
